CHECK OUT INSPECTION

Check out inspection for:		Comments &
The property address		Findings

A check out inspection has been carried out referring to a copy of an inventory dated 00/00/0000 and apart from any stains, marks, etc. mentioned on the inventory the following observations were also made:

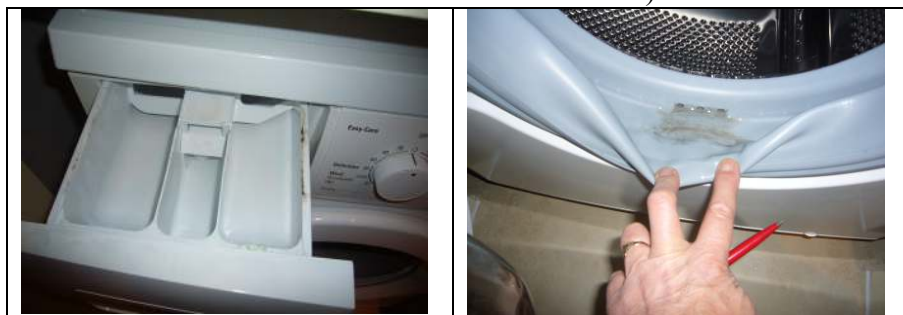
6. Pale wood flush veneer door opening to tank room with washing machine (**LIGHT DISCOLOURATION OF RUBBER DOOR SEAL AND SOME RESIDUES IN SOAP DRAWER OF WASHING MACHINE**).

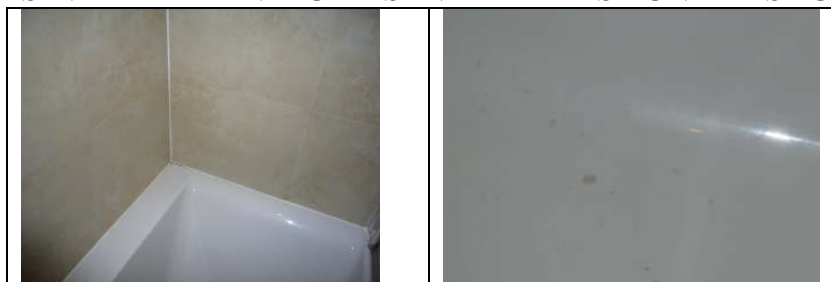
22. White acrylic bath with shower over and glass panel (**CHROME AND GLASS SMEARED, BOTTOM SHOWER SCREEN SEAL HEAVILY DISCOLOURED, ORANGE STAINING IN GROUT, MOULD MARKS IN SEALANT, AND SEVERAL HEAVY CHIPS IN BATH BASE UNDER SHOWERHEAD**).

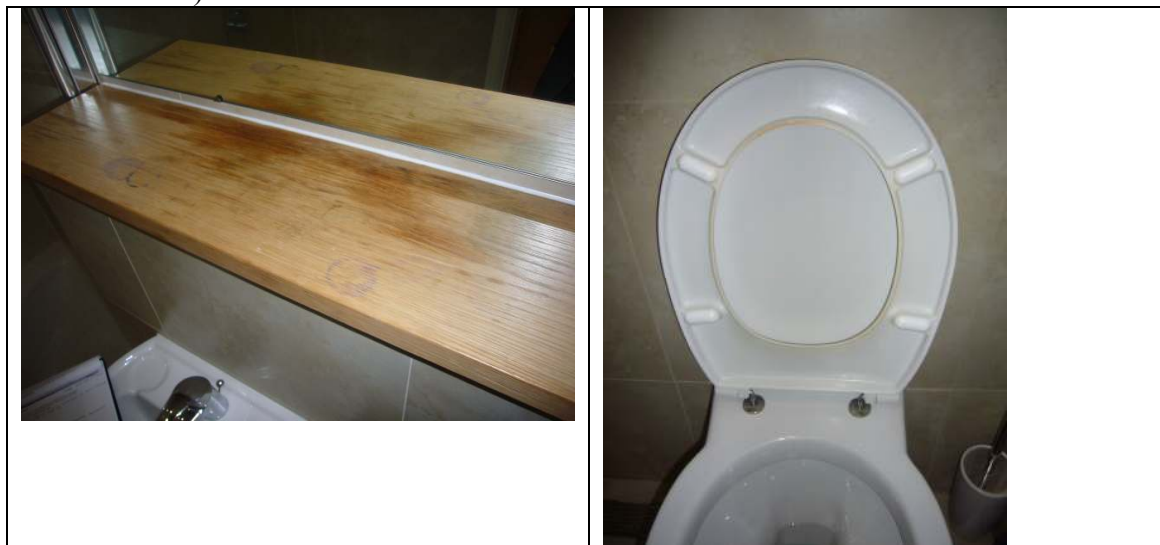
24. Concealed cistern in tiled boxing with pale wood shelf over, chrome pushbutton flush, and white ceramic pan with plastic seat (**DARK RING MARKS AND WATER STAINS ON WOODEN SHELF, CHROME SMEARED, SEAT COVER DRIP MARKED, UNDERSIDE OF SEAT STAINED, UNDERSIDE OF PAN NEEDS CLEANING**).

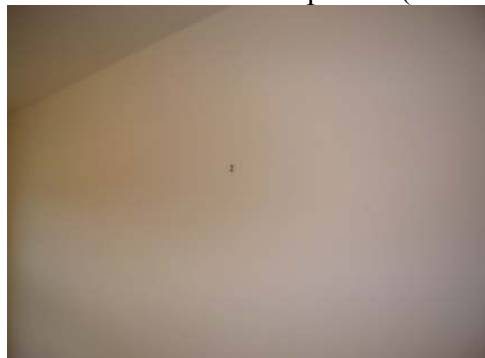
35. White emulsion on plaster (**TWO HOOKS**).

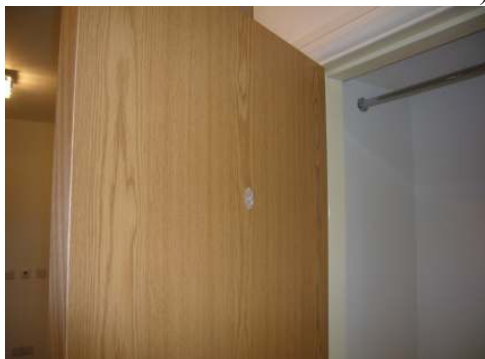
37. Double pale wood laminate flush doors opening to recessed wardrobe (**STICKY RESIDUES INSIDE LEFT DOOR**).

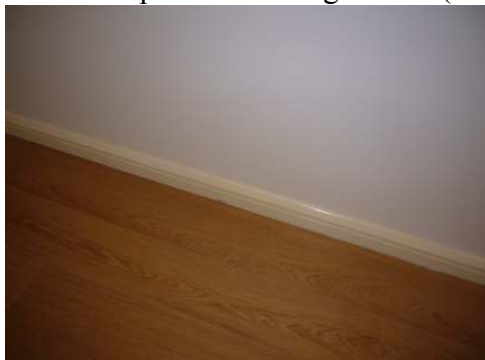
41. White painted skirting boards (**BLACK SCUFFS OPPOSITE DOOR**).

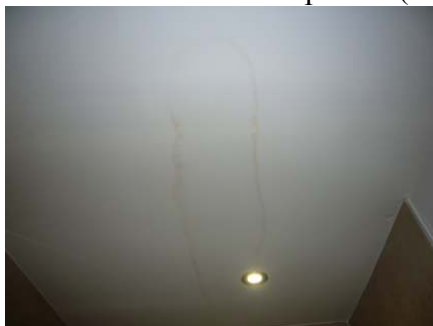
52. White emulsion on plaster (**WATER STAIN OVER SHOWER**).

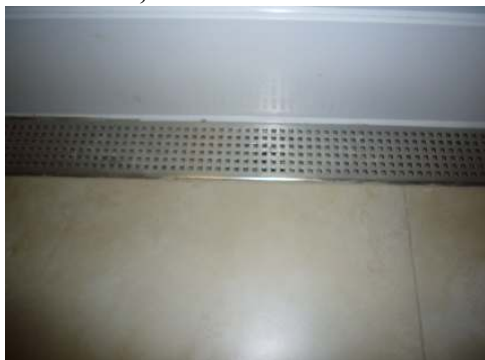
55. Beige stone effect ceramic tiles with stainless steel grille (**GROUT RESIDUES IN CENTRE, GRILLE SMEARED AND SCUFFED**).

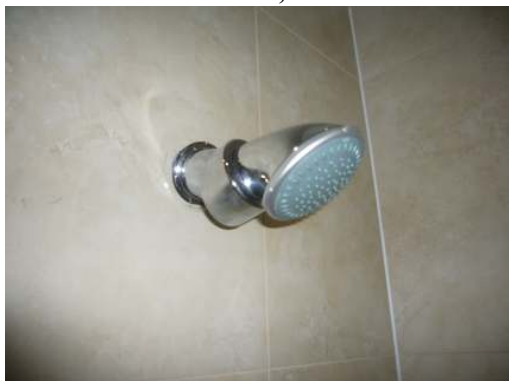
37. Shower enclosure with chrome shower (**CHROME AND GLASS SMEARED, DISCOLOURED PATCH IN CENTRE FRONT OF TRAY, SHOWER HEAD LOOSE ON WALL, SHOWER HEAD TRIM LOOSE**).

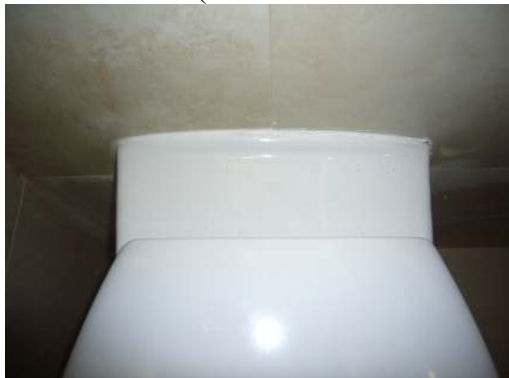
59. Concealed cistern with chrome push button flush, white ceramic pan with plastic seat and cover (**CHROME SMEARED, REAR OF PAN NEEDS CLEANING**).

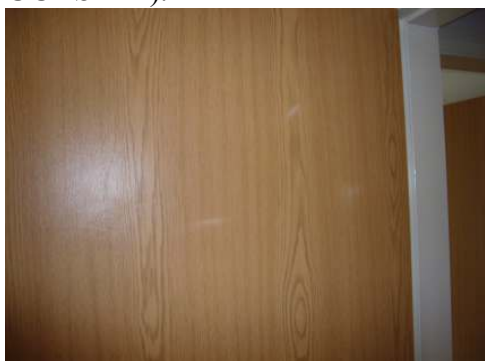
65. Pale wood laminate flush door (**THREE HEAVY RUB MARKS HIGH ON OUTSIDE**).

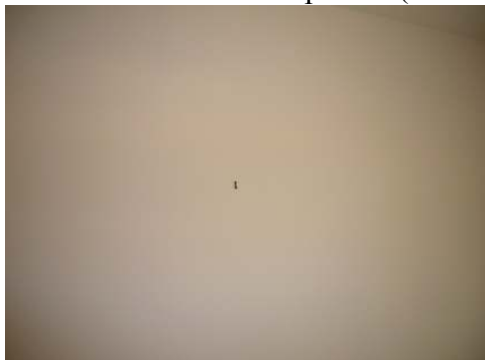
70. White emulsion on plaster (**TWO HOOKS**).

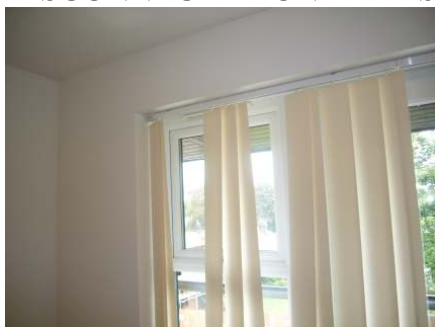
86. Floor length cream vertical blinds (**TWO TOP CONNECTOR STRIPS DISCONNECTED ON LEFT SIDE**).

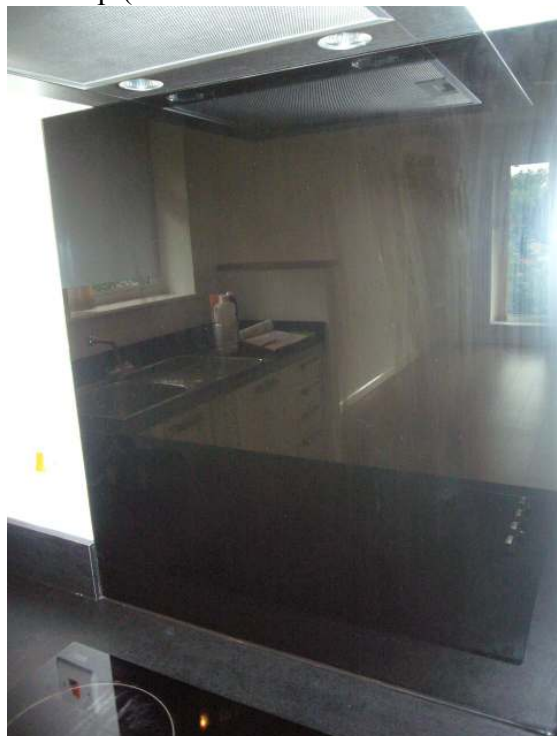
110. Gloss white flush fronts with black glass splash back and black stone effect worktop (**SPLASH BACK AND CUPBOARD FRONTS SMEARED**).

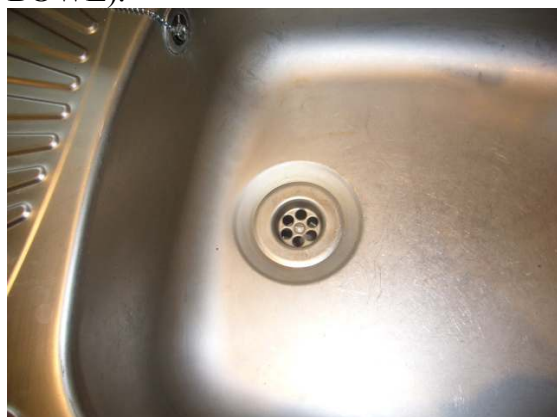
111. Stainless steel square sink and drainer (**SCRATCHED, BROWN STAINS IN BOWL**).

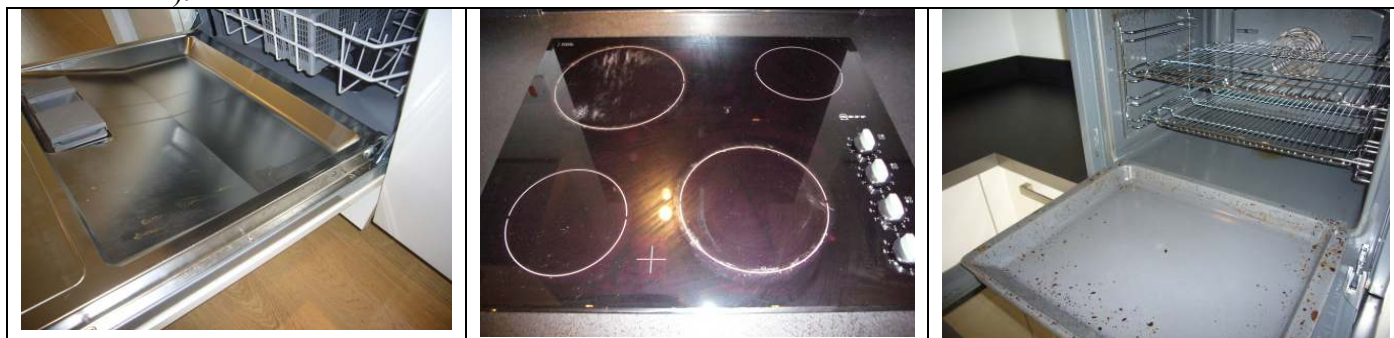
124. Neff dishwasher (**DOOR SIDES NEED CLEANING, CHROME GLASS IN DRAIN, DOOR SPRING BROKEN**).

126. Neff four burner halogen hob (**BACK RIGHT RING DAMAGED WITH SILVER BLOOM, BURNT ON FOOD AND SMEARS**).

127. CDA extractor (**GRILLES GREASY, STAINLESS STEEL AND GLASS PARTS SMEARED**).

128. Neff electric fan oven (**BURNT ON FOOD SPOTS ON INTERIOR LEFT SIDE AND GRILL PAN, EXTERIOR STAINLESS STEEL SMEARED**).

129. Neff fridge freezer (**GLASS SHELVES SMEARED, MELT WATER IN FREEZER**).
